ADVANCED MICROSCOPY TECHNIQUES FOR STUDYING THE DURABILITY OF FUEL CELLS

Laure Guétaz, Sylvie Escibano, Fabrice Micoud
CEA-LITEN, Grenoble, France

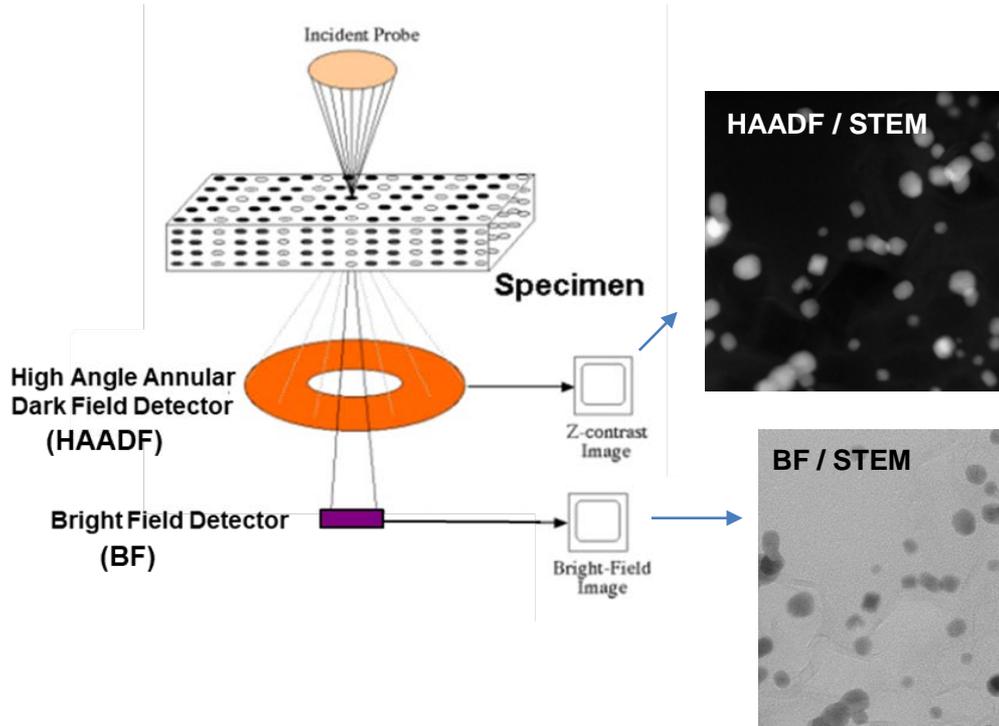
HAADF / STEM

Atomic resolution

Advantages of HAADF/STEM

- **Chemical contrast (Z-contrast)**: heavier atoms scatter electrons more intensely than lighter atoms
- Possibility to analyze the **chemical composition of the atomic columns** during the scan by **EELS** or **X-EDS**

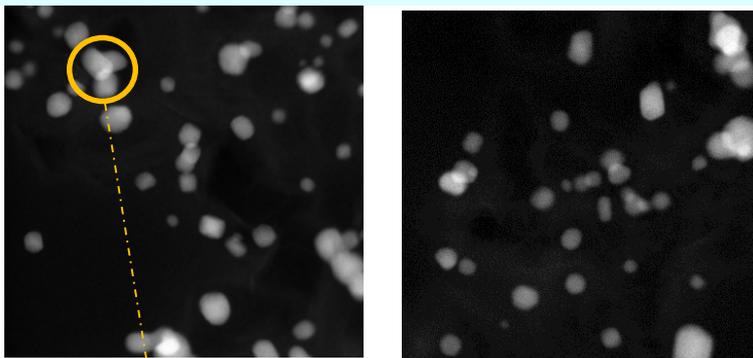
TEM or HAADF / STEM images

Nanoparticle size can be measured using image analysis software

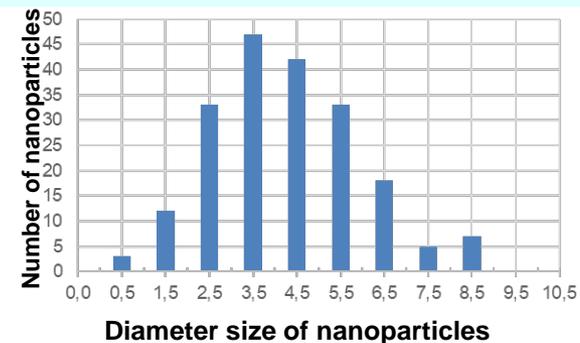
Nanoparticle size histogram

Nanoparticle size increases during fuel cell operation

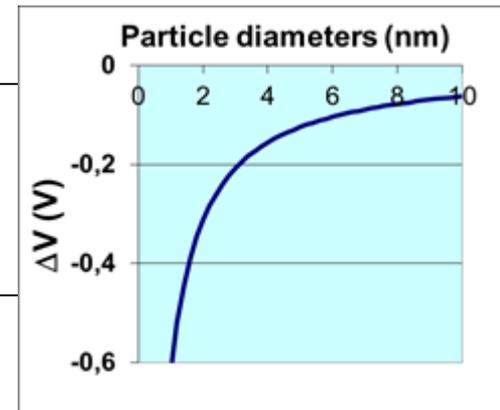
- ✓ Driven by the nanoparticle size dependence of the standard potential.

Negative shift in the standard electrode potentials of small nanoparticles (Plieth 1982)

- ✓ Migration of Pt ions (and electron transfer) between neighboring nanoparticles.
- ✓ Enhanced by liquid water content due to higher ionomer ionic conduction.
- ✓ Slows down when nanoparticles become larger.

Particles with diameters ≥ 4.0 nm are stable

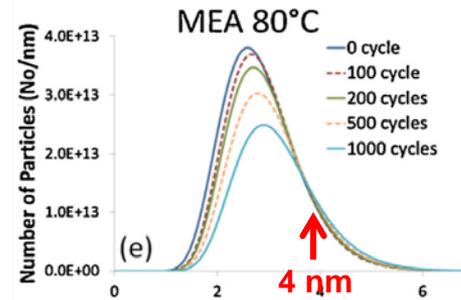
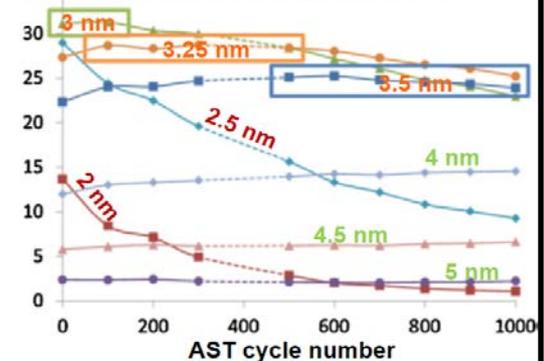
Nanoparticle size histogram evolution

Evolution of Pt NP number during AST for different NP diameters

Aged Cathode Histogram – Fresh Cathode Histogram

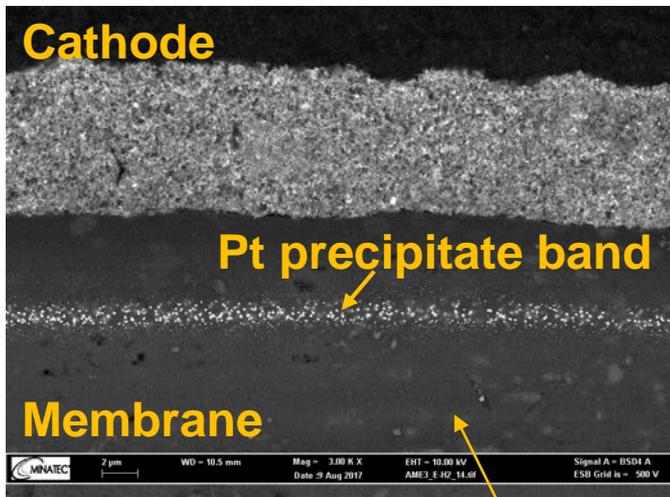
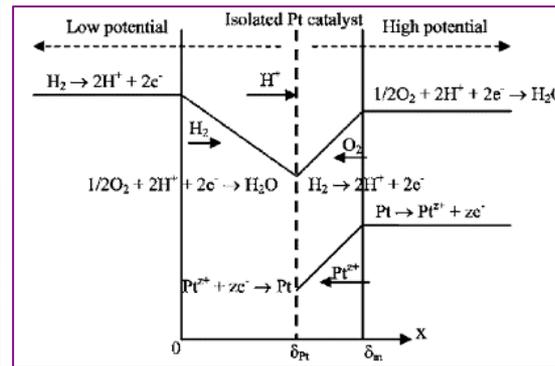
Formation of a Pt precipitate band

For potential larger than 1 V, a large amount of Pt is dissolved

1. Pt ions migrate toward the membrane
2. Pt ions are reduced by H₂ crossover

- The position of this band depends on H₂/O₂ crossover.
- It is located where the crossover molar flux of O₂ equals one half of the crossover molar flux of H₂

Small precipitates also appear in the whole area between the band and the anode.

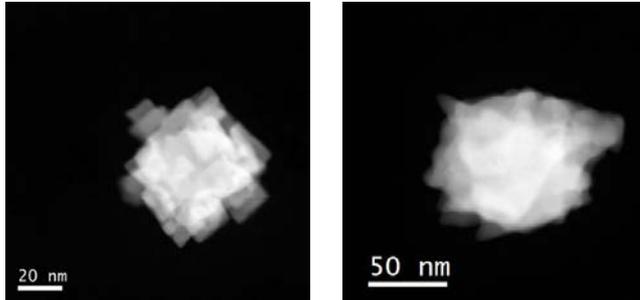
Shape close to the cube

Lower Pt ion flux ⇒ shape close to the cube

The precipitate shape probably results from the intensity fluxes of the Pt ions and/or H₂

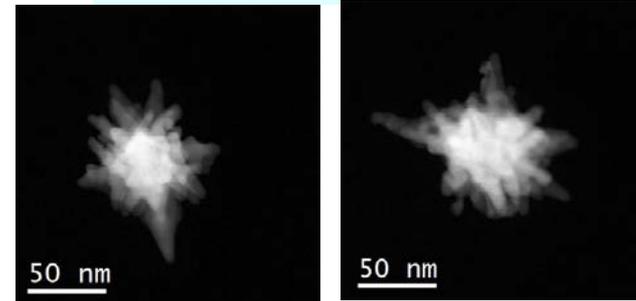
Star/dendritic shape

Higher Pt ion flux ⇒ star/dendritic shape

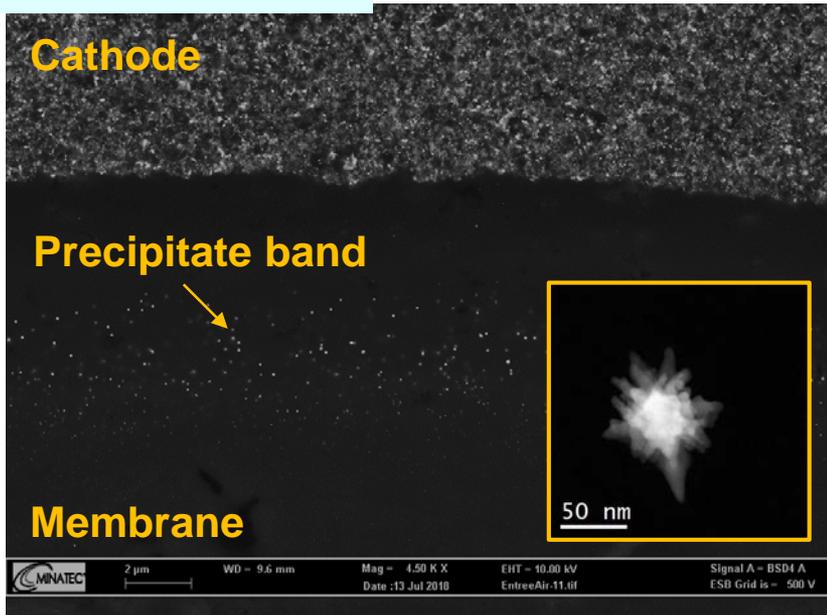
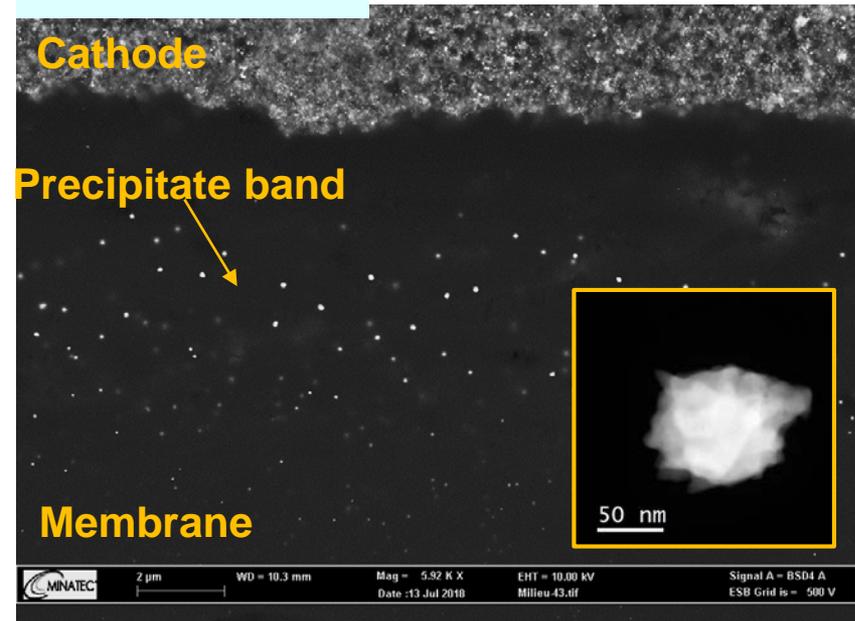
Air Inlet zone

Middle zone

The precipitate star/dendritic morphology indicates that probably a high-potential phase occurred during start/stop steps

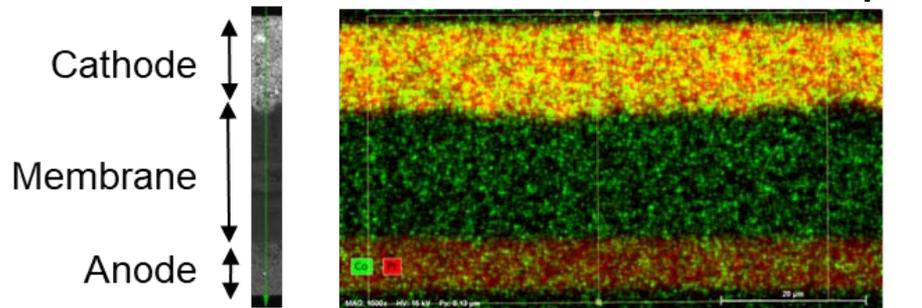
Pt and Co X-EDS elemental maps

Fresh MEA

No Co cation are detected in the membrane of the fresh MEA

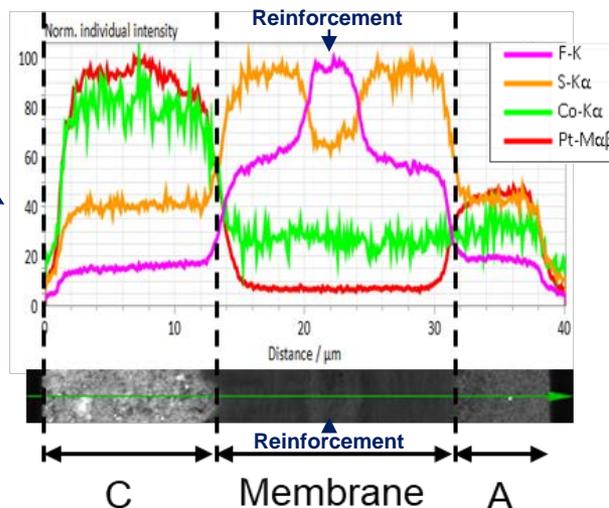
Lines scan across the MEA

The membrane contamination can be detected on MEA cross-section by X-EDS analysis in a SEM

In order to avoid the contamination of the membrane during the sample preparation, the embedded cross-section was cut by microtomy in dry conditions

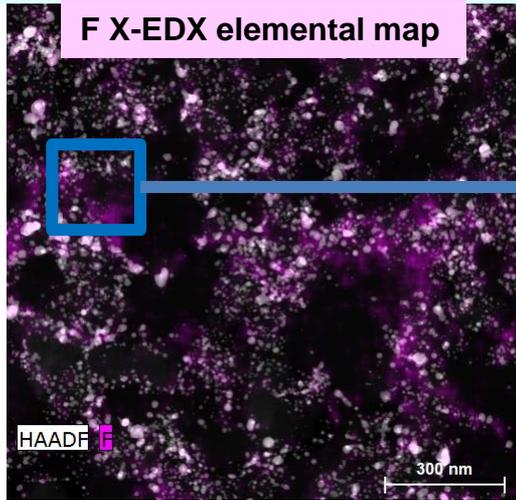
HAADF/STEM image of the cathode

The ionomer in the cathode could be even more contaminated by Co cations than the membrane

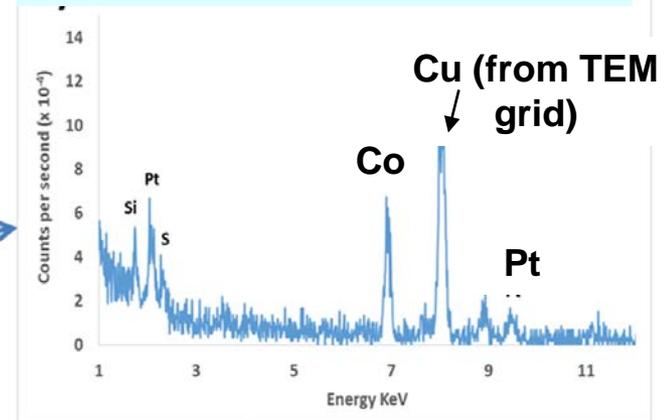
EDS spectrum in the pore filled with Nafion

Large amount of Co is detected in the pore filled with Nafion

To reduce the ionomer contamination, it is important to lower the Co content in the catalysts (~10 at.% Co instead of 25 at.%)

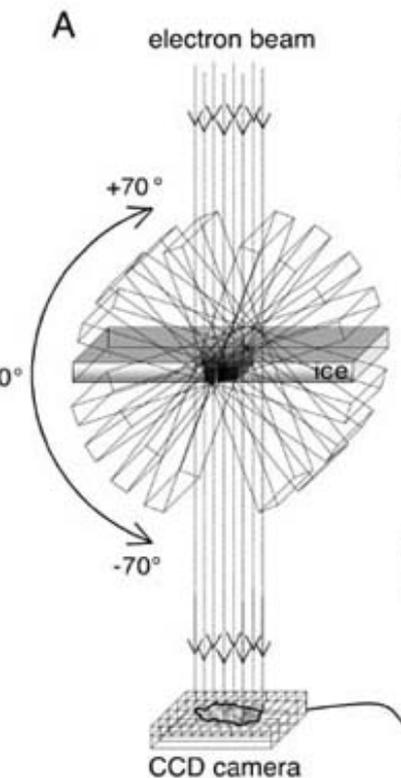
Electron tomography analyses have shown that for the high surface area carbon (HSAC) support, many nanoparticles are located inside the carbon

Tilt series of images is recorded

3D structure of the specimen is computed

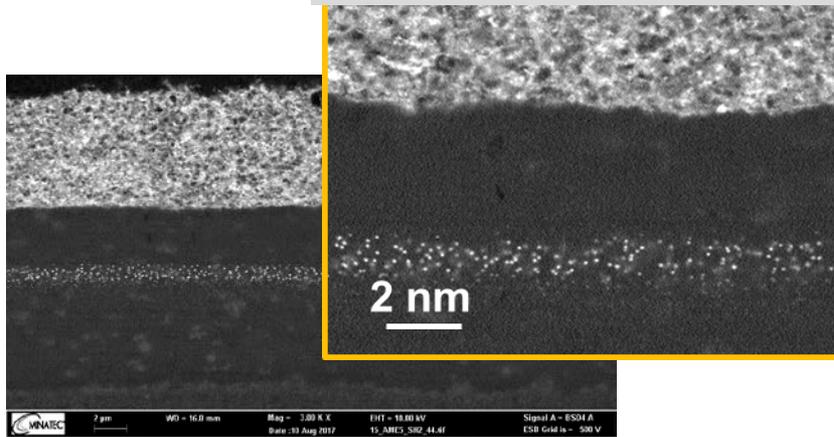
Cathode without compaction

Carbon corrosion can change the position of the membrane Pt band

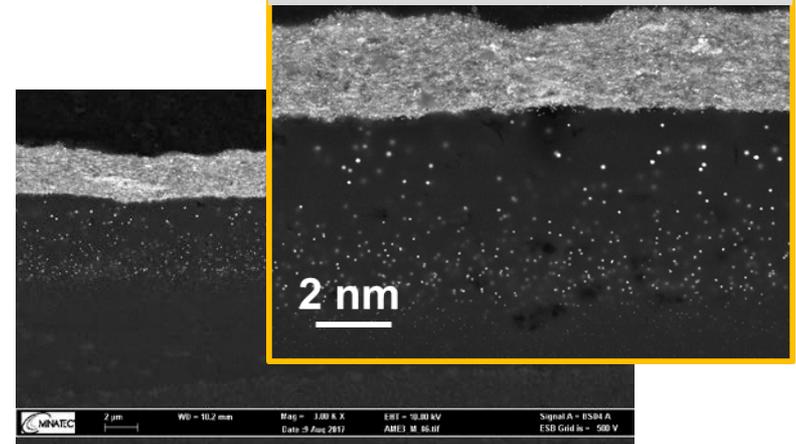
Compaction of the cathode

- Pt precipitates closer to the cathode revealing the presence of H₂ nearby the cathode / membrane interface
- That indicates that no more O₂ could diffuse into the membrane due to cathode compaction.

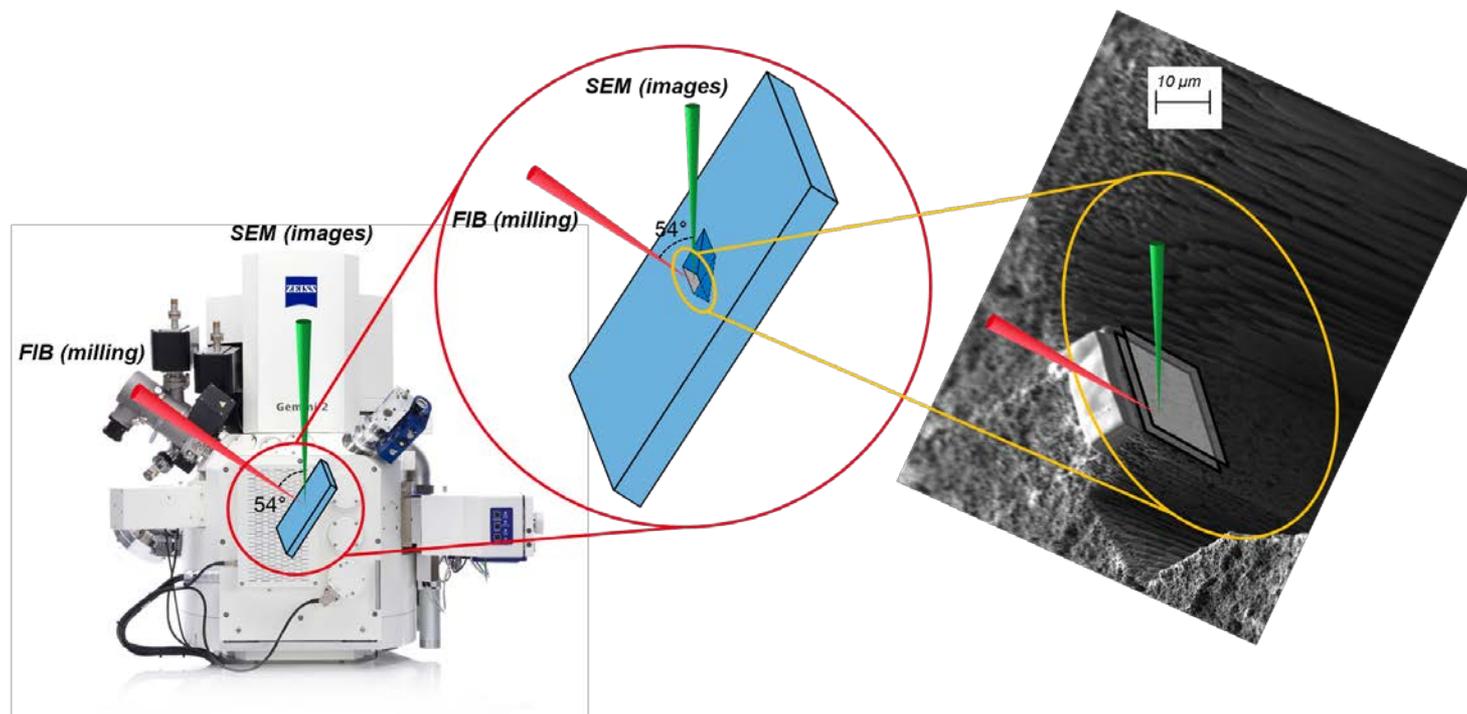
Cathode compaction can be analyzed quantitatively by measuring the evolution of cathode porosity

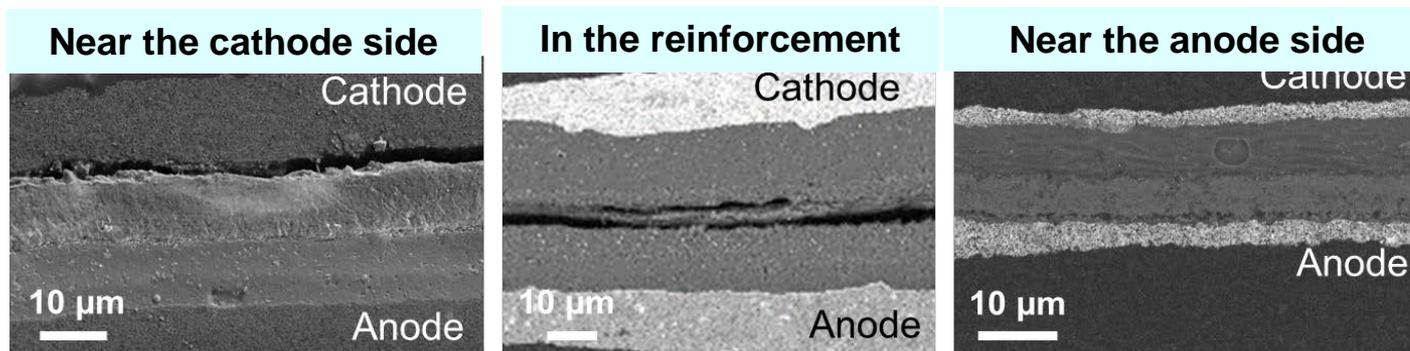
Membrane degradation can occur at different locations

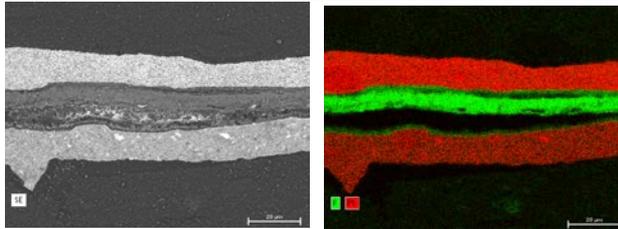
The epoxy resin can fill the voids left by the membrane degradation : light contrast between membrane and epoxy resin

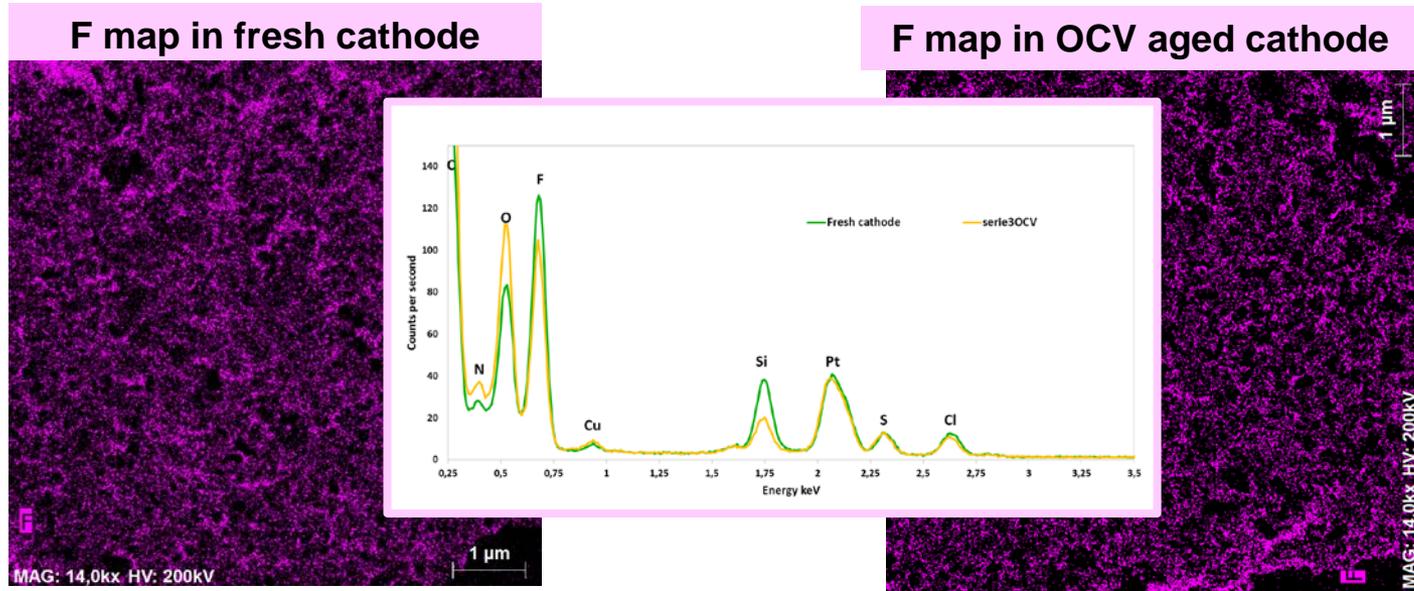
Comparison of F content in the fresh and aged cathodes

Fluorine EDS elemental maps are acquired using low electron dose at cryogenic temperature

Quantitative analysis (at.%):
 $F/Pt = 88/12$

Quantitative analysis (at.%):
 $F/Pt = 87/13$

➔ No degradation of the Nafion is detected in the cathode aged under OCV conditions, even if severe membrane degradation was observed
